# Fracture Characteristics of Angleplied Laminates Fabricated From Overaged Graphite/Epoxy Prepreg

Carol A. Ginty and Christos C. Chamis  
*Lewis Research Center*  
*Cleveland, Ohio*

Prepared for the  
Symposium on Fractography of Modern Engineering Materials  
sponsored by the American Society for Testing and Materials  
Nashville, Tennessee, November 18-19, 1985

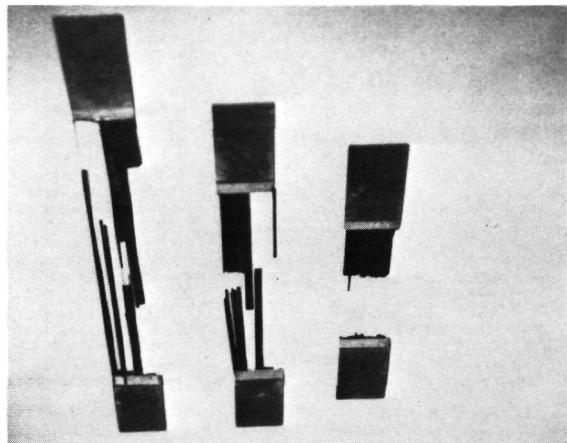
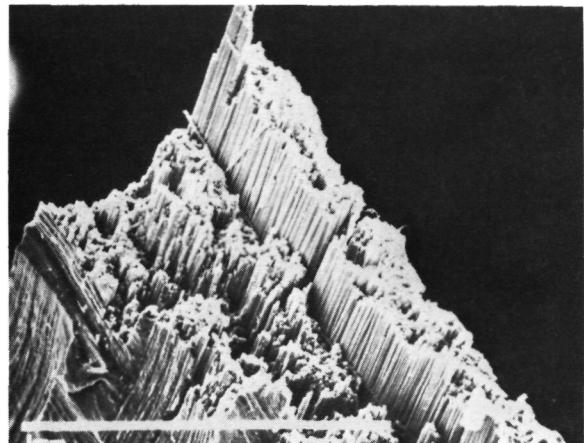
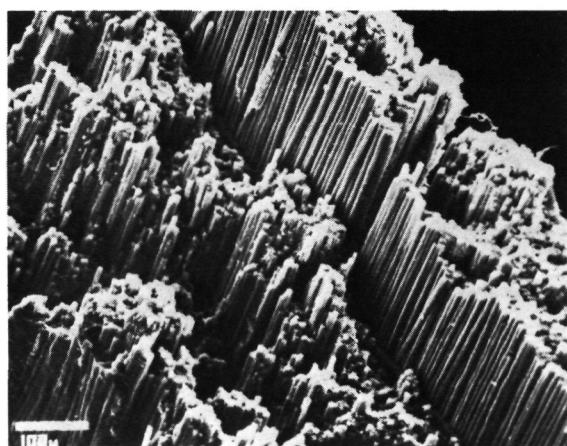
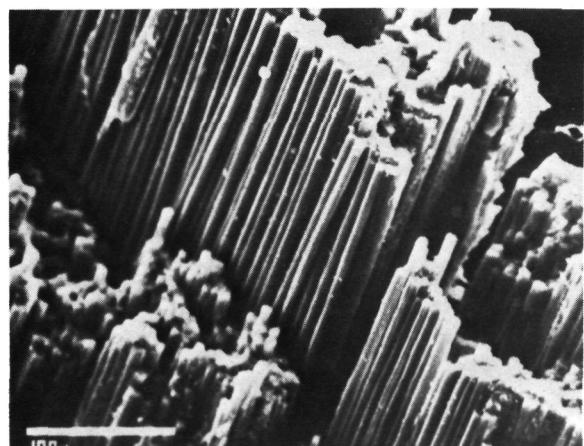
The fracture characteristics of the  $[0]_4$  specimens are shown in figure 1. The laminate experienced a catastrophic fracture, leaving very little of the specimen intact. The dominant microstructural characteristic on the fracture surface is the tiered fibers resulting from fibers breaking at various locations along their lengths. The photomicrographs show that the tiered fiber surfaces are clean and free of matrix residue, indicative of debonding between the fiber and matrix.

Figure 1. - The fractured specimens and typical microstructural characteristics for the  $[0]_4$  laminate.

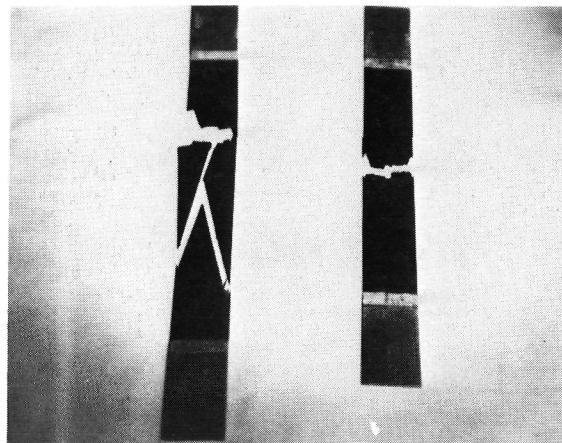
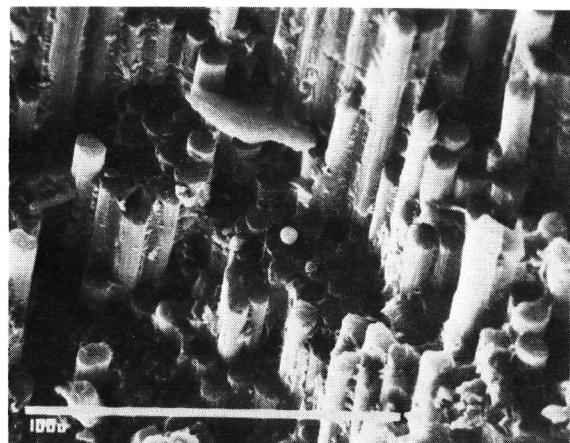
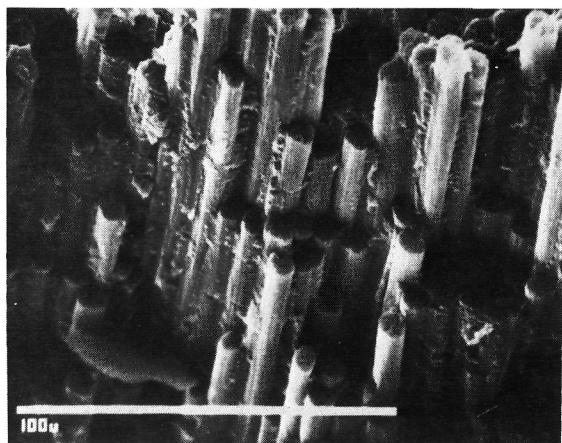
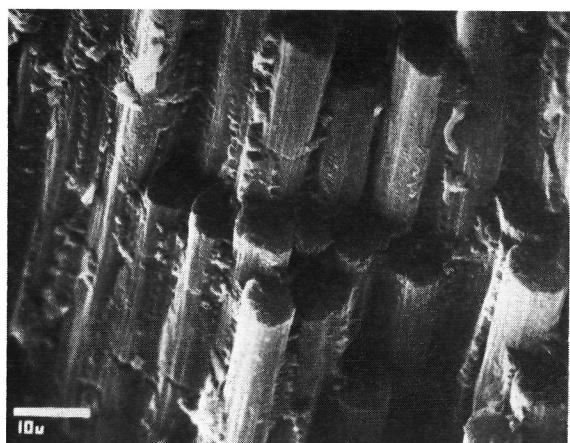
Figure 2 displays the fracture surfaces of the  $[\pm 15]_S$  laminates. The laminate fracture occurred across the widths of the specimens. For the notched specimens, the fracture progressed through the notch itself. Analysis of the photomicrographs revealed an irregular fracture morphology consisting of broken fibers, fiber pull-out, and some matrix hackles.

Figure 2. - The fractured specimens and typical microstructural characteristics for the  $[+15]_s$  laminate.

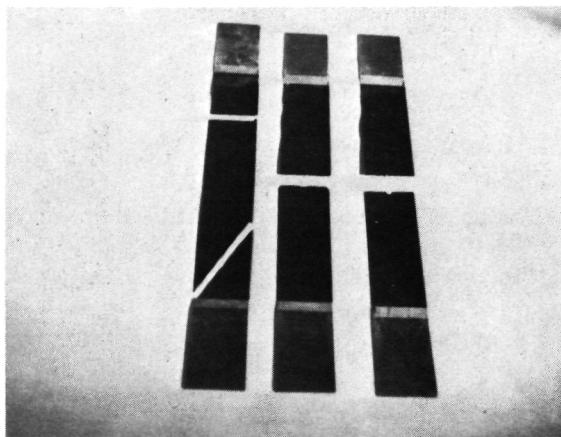
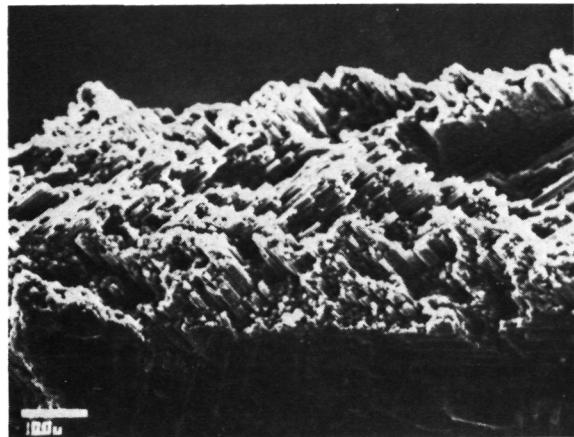
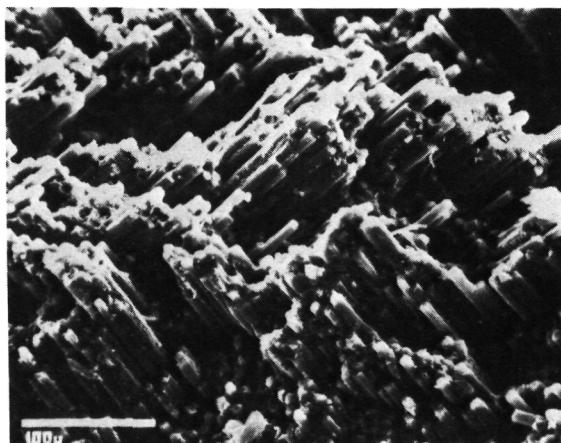
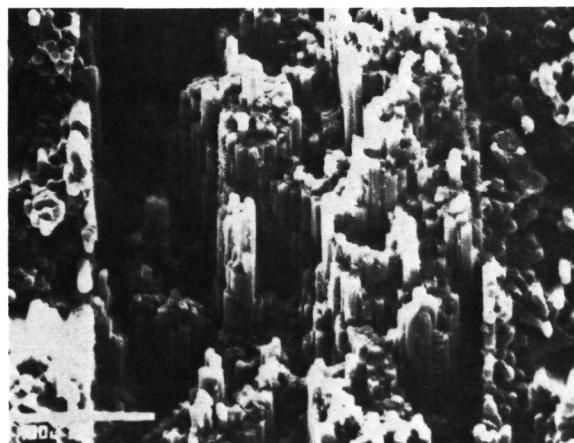
The fractures of the  $[+30]_S$  specimens also occur through the notches and across the widths as shown in figure 3. Both the inner (-30) plies and outer (+30) plies exhibit fiber pull-out and fiber breakage in different locations. The morphology for the  $[+30]_S$  laminate is irregular and similar to that observed for the  $[+15]_S$  laminate.

Figure 3. - The fractured specimens and typical microstructural characteristics for the  $[+30]_S$  laminate.

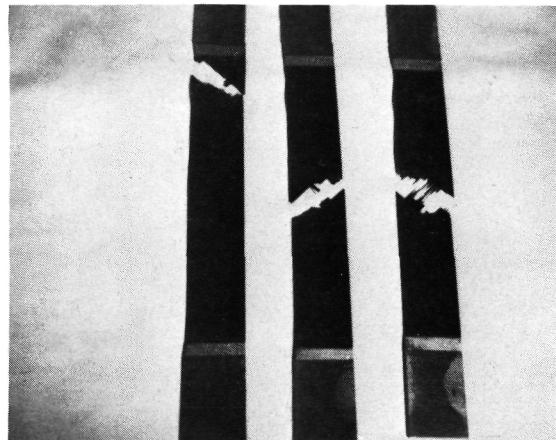
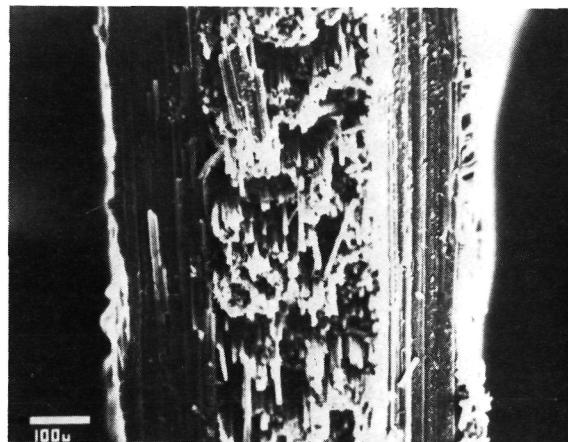
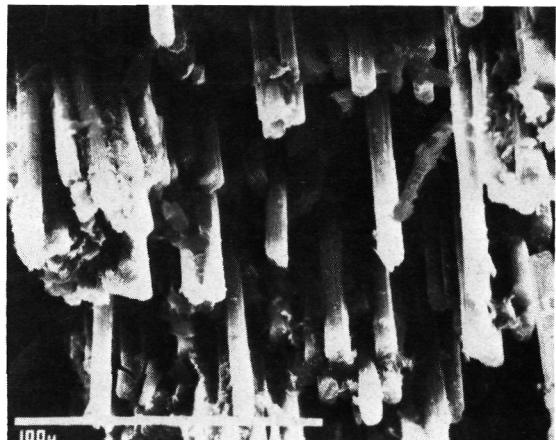
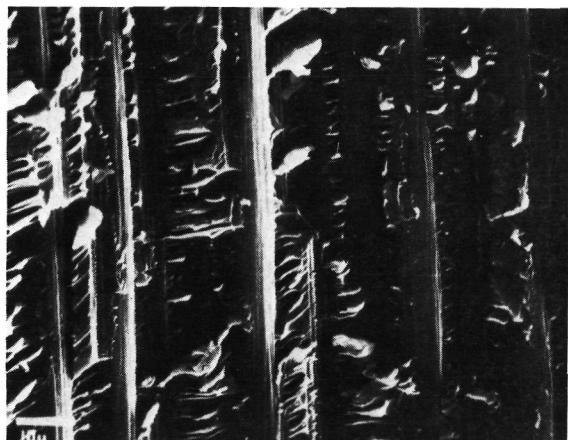
In figure 4, the  $[+45]_S$  specimens fractured along a plane parallel to the fiber direction and through the notches. The morphology consists of a flat surface on the outer plies which exhibit an extensive amount of hackles in contrast to the irregular surface on the inner plies which experience pulled-out fibers.

Figure 4. - The fractured specimens and typical microstructural characteristics for the  $[+45]_S$  laminate.

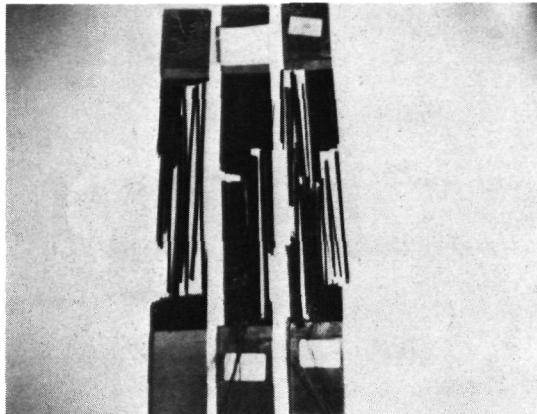
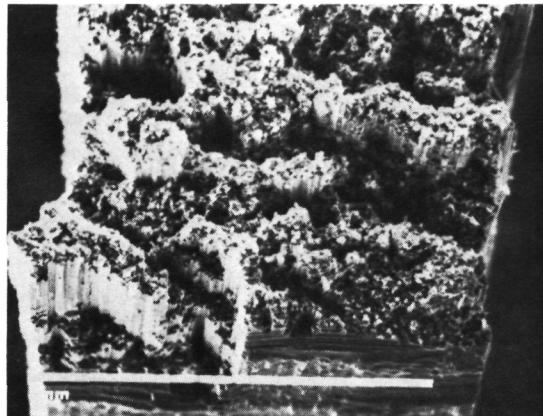
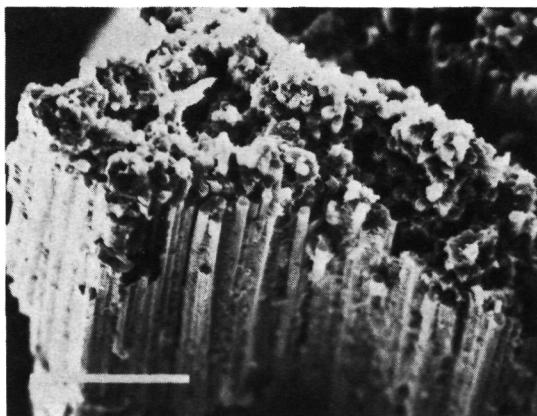
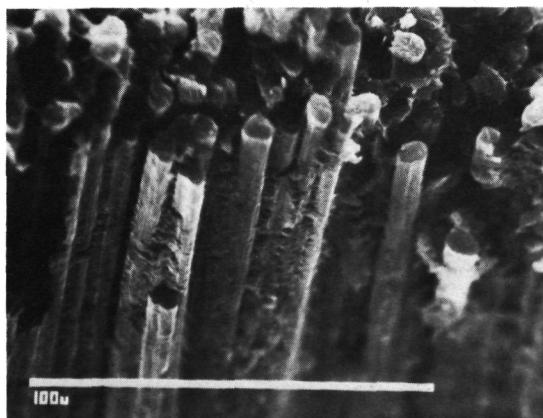
Having observed the severe strength degradation in terms of fracture stress, the fracture surfaces were examined using a scanning electron microscope (SEM) to document microstructural characteristics associated with overaged prepreg. Figure 5 displays the fracture surface and microstructural characteristics for the  $[0]_8$  laminate. The fracture resulted in splintery pieces. Under magnification these pieces exhibit an irregular morphology. The fibers are broken in bunches at various locations, forming a patchy pattern on the surface. Higher magnifications reveal extensive matrix hackles and debris.

The unidirectional laminate ( $[0]_8$ ) did exhibit some degradation in strength; however it was slight in comparison to that of the angleplied laminates. As previously mentioned, the resin is found to be more sensitive to overaging. Since the unidirectional laminate is fiber dominant, the degradation was expected to be minimal. This is manifested in comparing the photomicrographs of the two laminates. One would expect the microstructural characteristics of the  $[0]_8$  laminate in figure 5 to be very similar in

nature to those of the  $[0]_4$  laminate in figure 1 since both laminates are fiber dominant. The unidirectional laminate made from the overaged prepreg does possess the fiber breakage and tiered pattern which was documented for the  $[0]_4$  laminate. However, the alternating fiber/hackle pattern is also present in the patchy areas of the surface which, in this paper is shown to be associated with an overaged prepreg.

Figure 5. - Fracture characteristics associated with an overaged  $[0]_8$  laminate.

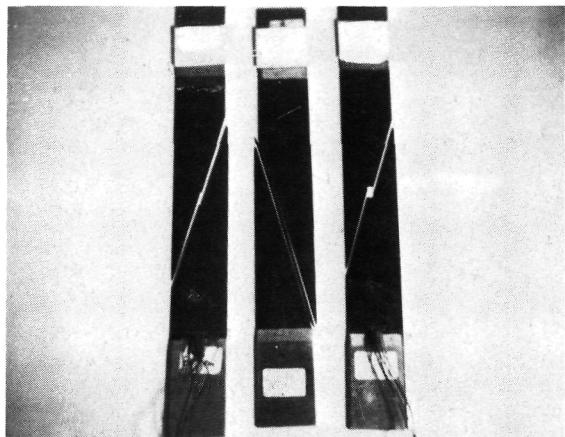
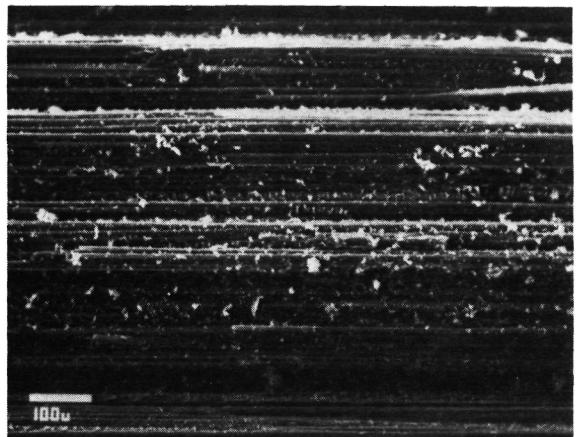
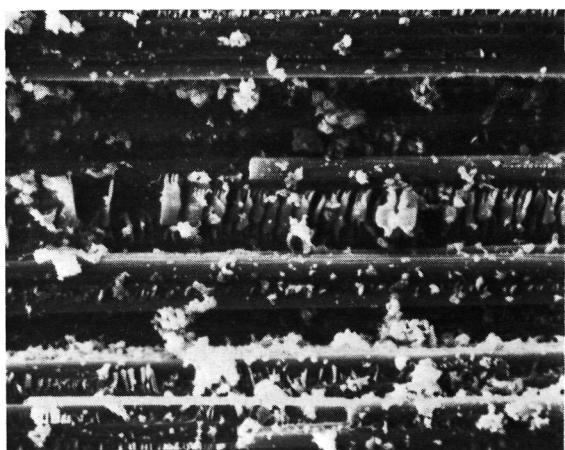
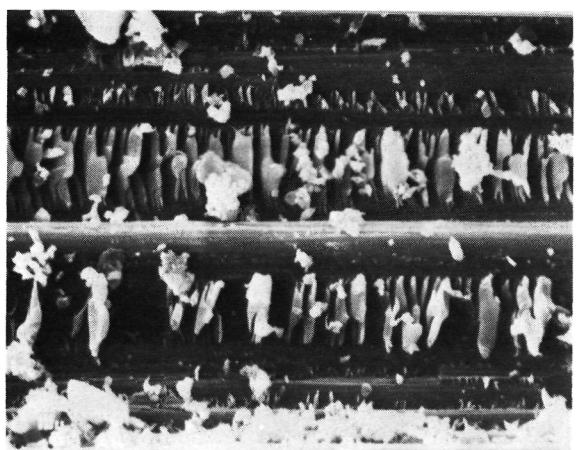
The  $[\pm 15_2]_S$  specimens displayed in figure 6 fractured at an angle parallel to a fiber direction. For the notched specimen, the fracture split the specimens into two equal halves. Photomicrographs reveal a flat morphology. Even at lower magnifications, an extensive amount of matrix debris is visible. At higher magnifications, an alternating pattern of rows of fibers and hackles exists. Very few broken fibers were observed. In the presence of a broken fiber, the hackles were larger in size than others in the same view.

Figure 6. - Fracture characteristics associated with an overaged  $[+15_2]_S$  laminate.

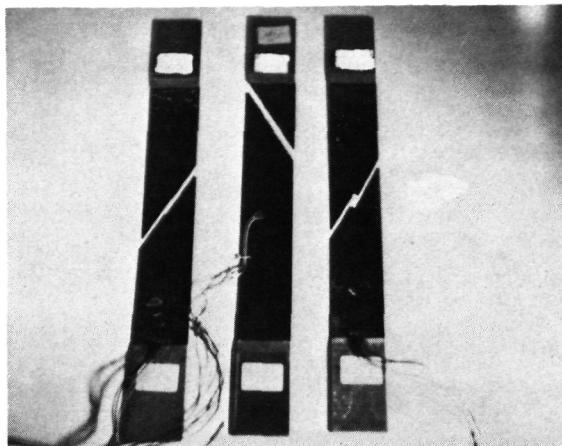
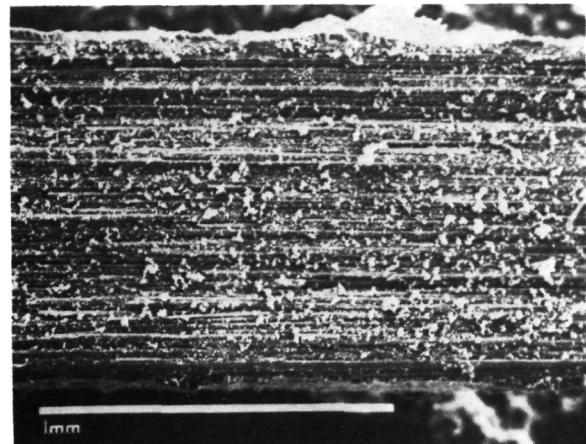
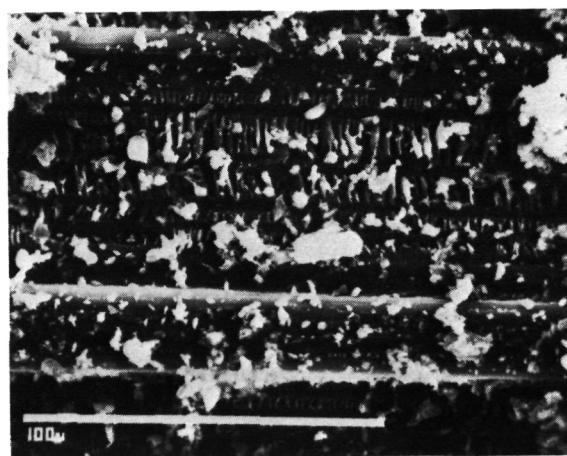
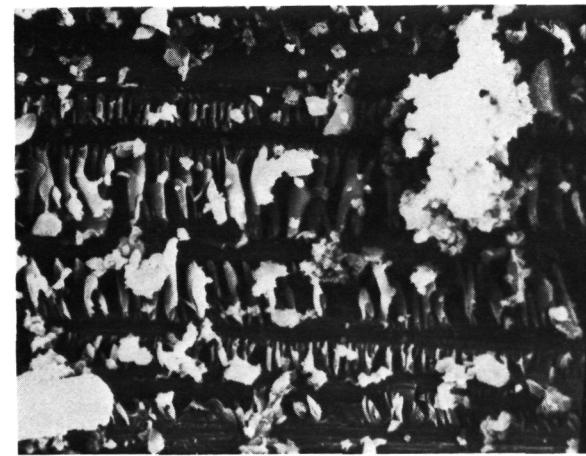
Basically, similar fracture characteristics were observed for the  $[\pm 30_2]_S$  laminate shown in figure 7. Once again the specimen fractured along a line parallel to a fiber direction. For those specimens containing notches, fracture progressed through the center of the machined notches. The morphology of the fracture surface is flat consisting of rows of fibers and hackles. All hackles in a row appear to be the same size; however, the size of the hackles varies from row to row. Very little fiber fracture was observed on this surface.

Figure 7. - Fracture characteristics associated with an overaged  $[+30_2]_S$  laminate.

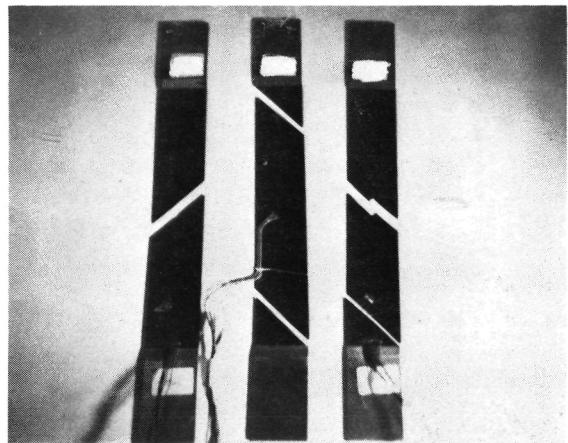
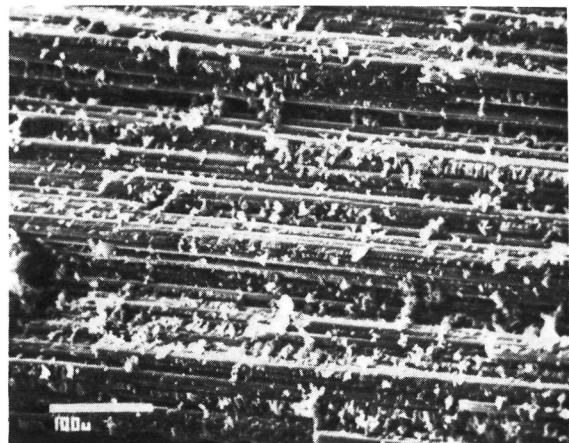
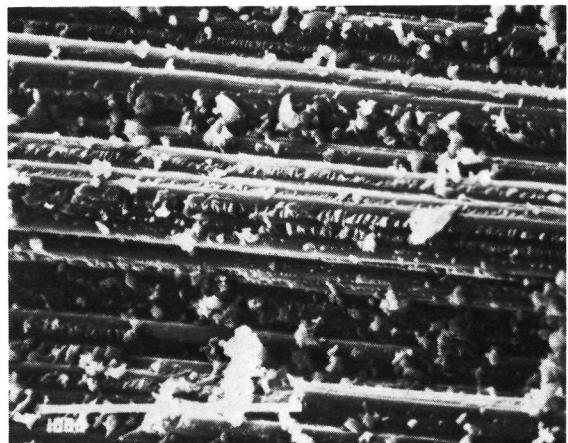
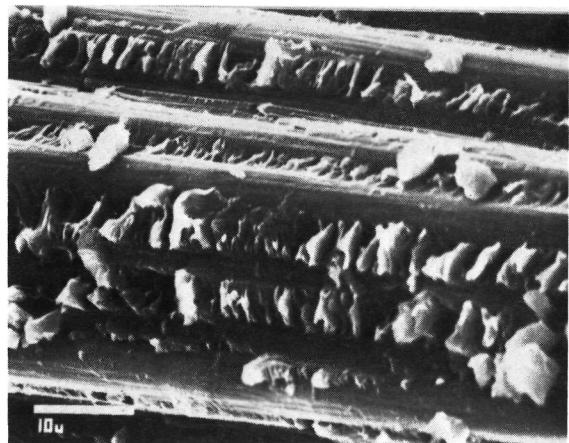
In figure 8, the characteristics associated with the fracture of the  $[\pm 45_2]_S$  laminate are displayed. Again, the specimens fracture in the same manner previously observed. The angle of fracture coincides with the 45° orientation of the fibers. The fracture surface is flat and littered with matrix debris. The fibers and hackles alternate in rows where the sizes of the hackles are varied throughout each row.

Figure 8. - Fracture characteristics associated with an overaged  $[+45_2]_S$  laminate.

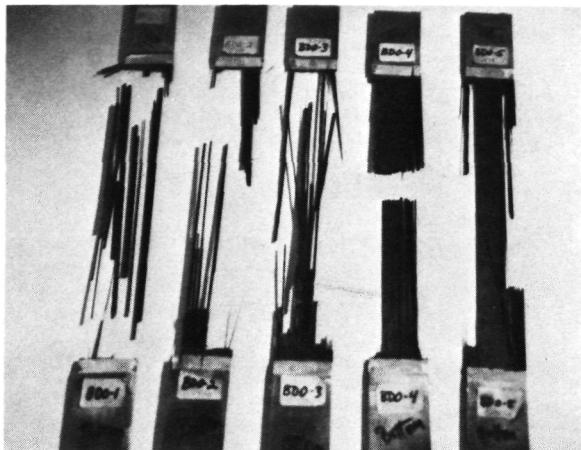
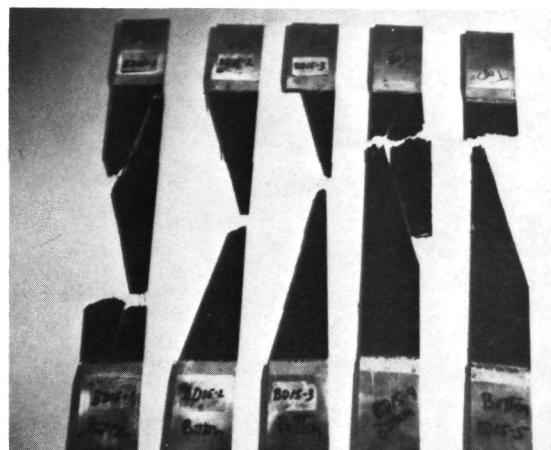
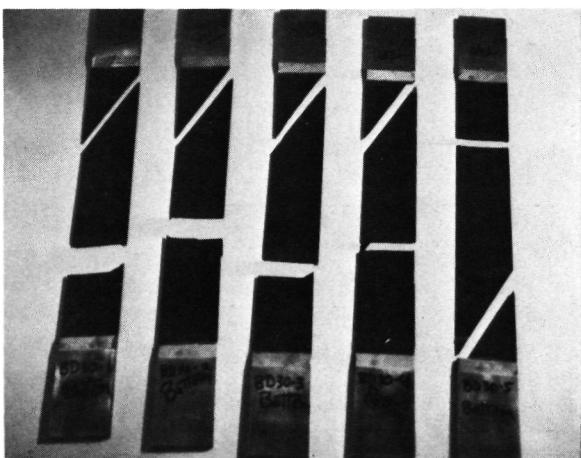
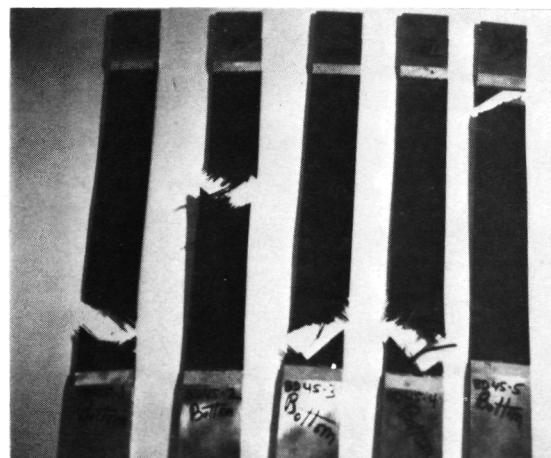
Finally, the physical fracture characteristics of these specimens shown in figure 9 resemble those previously photographed for the  $[+0]_S$  laminates. Primarily, the specimens are breaking at two different locations producing jagged, irregular surfaces.

Figure 9. - Fractured graphite/epoxy specimens fabricated from a fresh batch of prepreg.

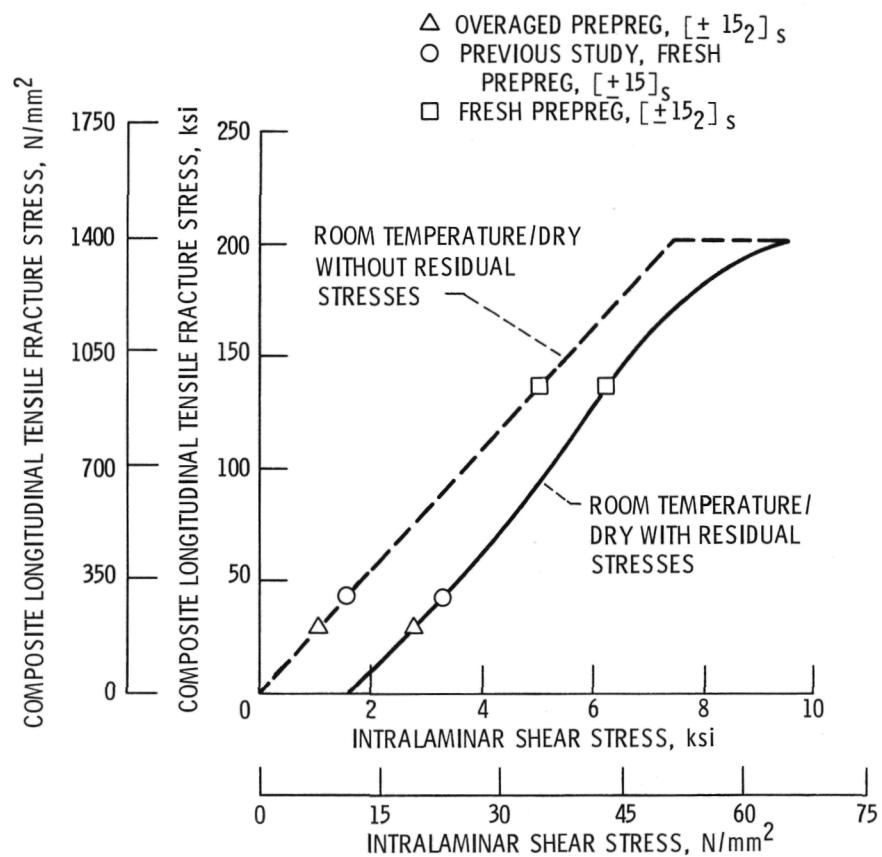
The analytical results in figures 10 and 11 show that for the actual fracture stresses the corresponding intralaminar shear stresses associated with the overaged laminates are lower than the thinner  $[+0]_S$  laminates and substantially lower than those made with fresh prepreg. As expected, the degradation in shear strength is more severe for the  $[+302]_S$  and  $[+452]_S$  laminates. The only factor separating the data points is the age of the prepreg. Since the intralaminar shear strength is a property of the resin primarily, the analytical results indicate that the degradation in shear strength is the result of a deteriorating resin which is caused by overaging.

Figure 10. - Composite fracture stresses as a function of intralaminar shear stress for the laminates where  $\theta = 15^\circ$ .

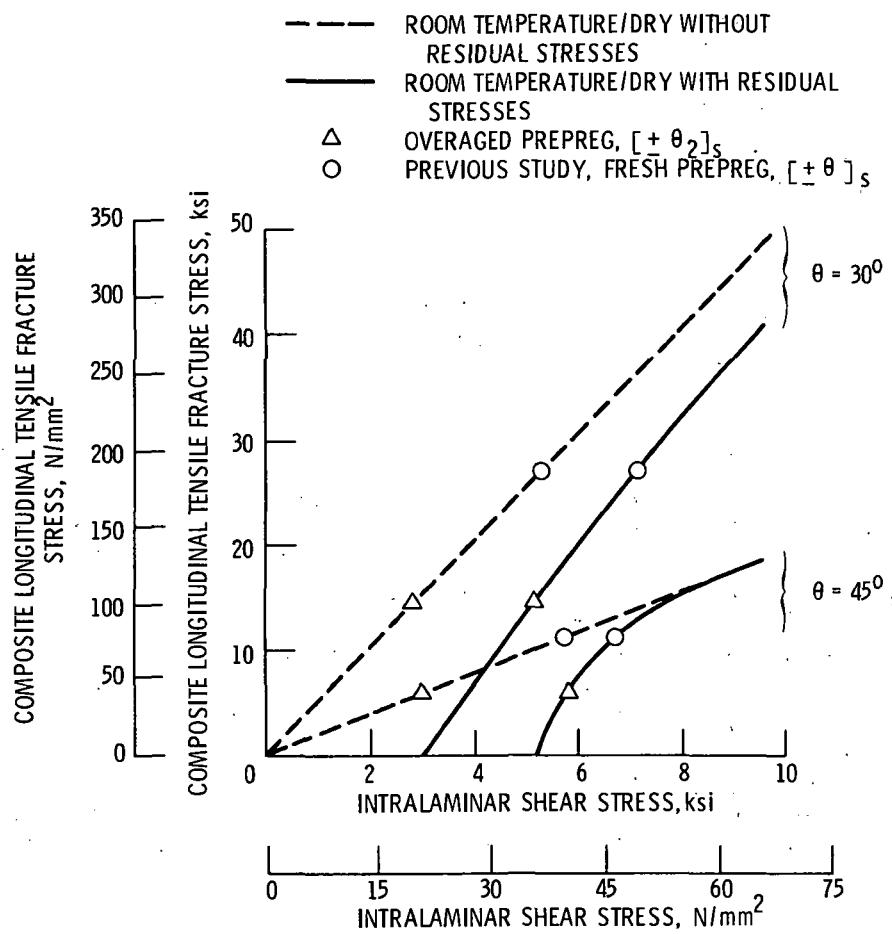
Figure 11. - Composite fracture stresses as a function of intralaminar shear stress for the laminates where  $\theta = 30^\circ$  and  $45^\circ$ .
